Geotechnical investigation of the 2017 earth-filled embankment failures in Thailand

Peangta Satarugsa*, Kiattisak Sonpirom, Phopthorn Maneepong and Natthawiroj Silaratana

Department of Geotechnology, Faculty of Technology, Khon Kaen University, Khon Kaen, Thailand

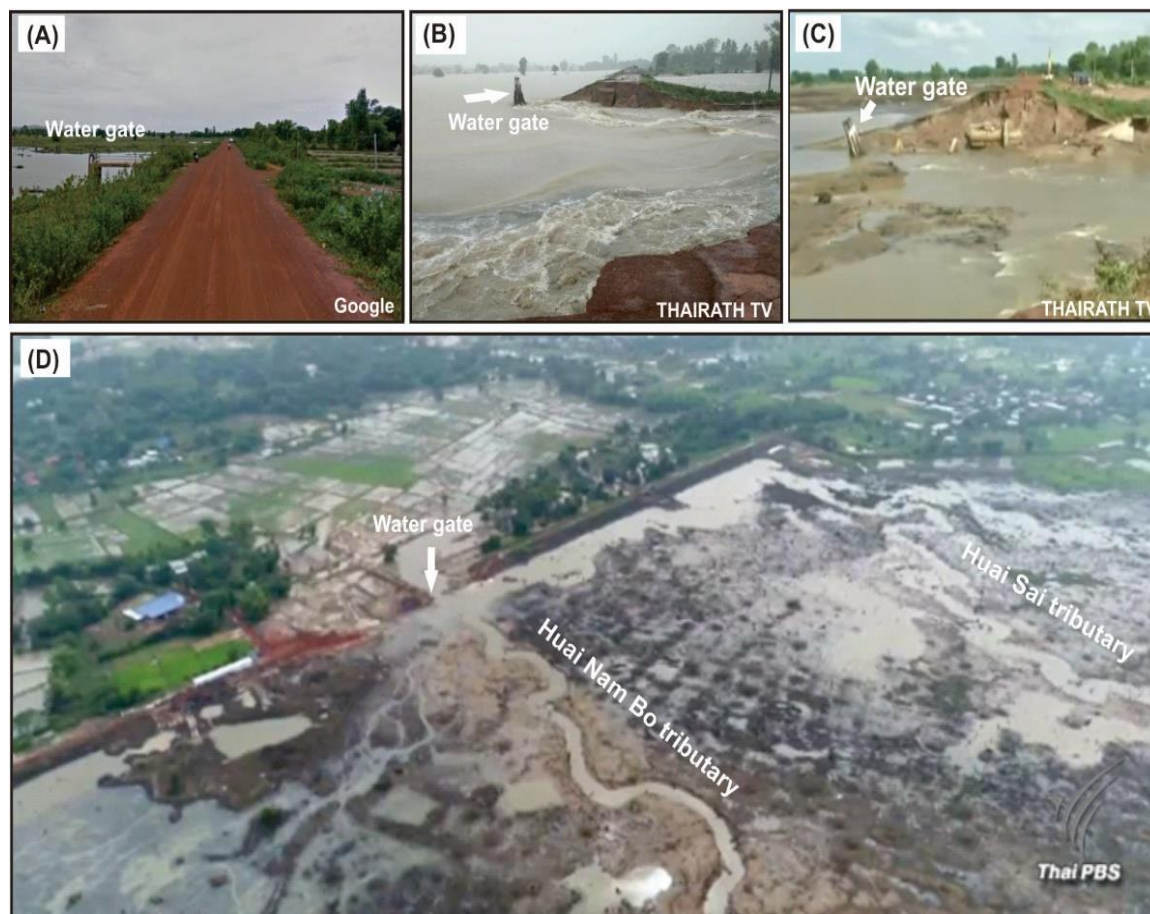
(Figure 1). The breach of the Huai Sai Kamin dam was due mostly to water overtopping during a strike of a tropical depression, Sonca. Another notable dam breach incident occurred on October 18th at the Nong Sano reservoir, Lopburi province (Figure 2). The breach of the embankment of the Nong Sano reservoir was due to piping erosion at which time the reservoir water level was raised nearly to the maximum capacity of the reservoir. During storms or depressions, there were breaches of road embankments in several places. However, such road damages were often restored within a relatively short time period. Consequently, the failure of road embankments drew less public attention than the failure of dams or failure of water reservoir embankments. The failure of these two embankments attracted public attention and a call for dam safety assurance.

Figure 1 (A) Photograph of the Huai Sai Kamin dam taken in June 2015 from the Google Map showing the embankment crest, fillings in the reservoir and the water gate where the left conduit installed beneath the embankment [9], (B) and (C) photographs of the dam taken in the morning and in the afternoon of July 28th, 2017 after a breach incident occurred, the water gate shown in (A) was collapsed [10-11], (D) an aerial view taken on July 31st, 2017 showing the dam no longer held water and the remnant of Huai Nam Bo tributary that ran through the embankment [12].

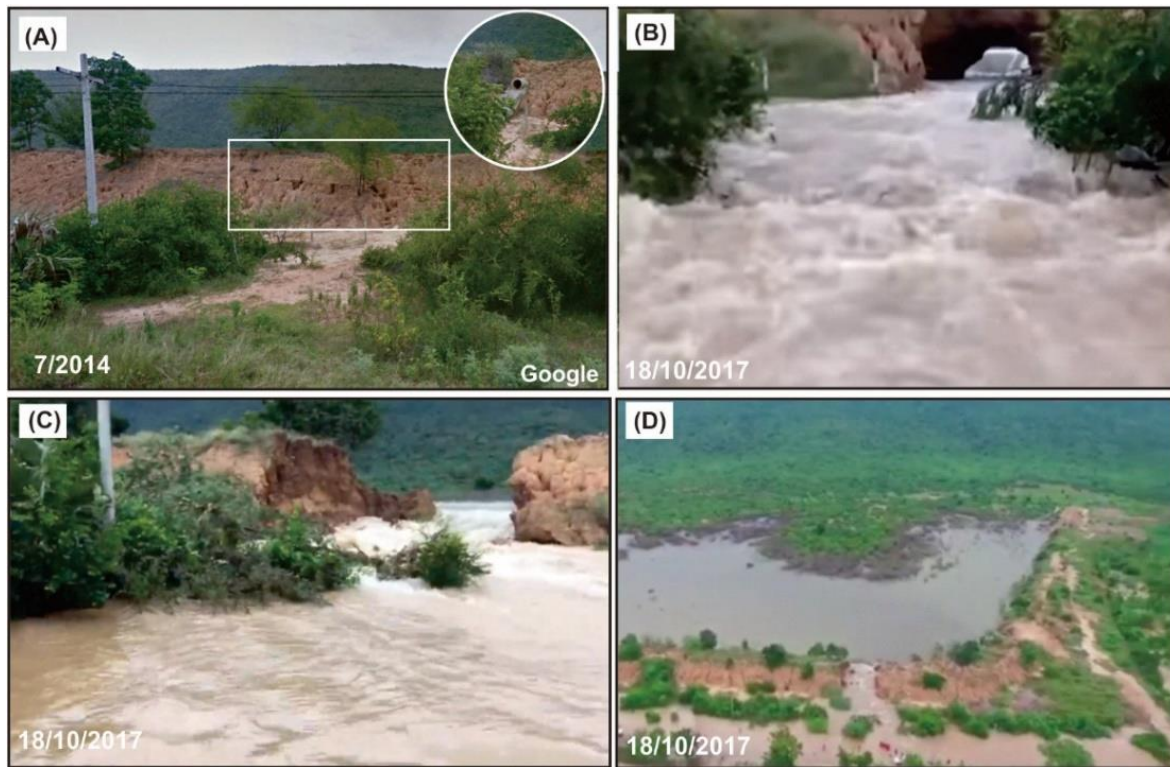
Figure 2 (A) Photograph of the embankment of the Nong Sano reservoir taken in July 2014 from Google Map, a square box outlined an approximate breached location that occurred in October 18th, 2017, an inserted photo showing a conduit installed for water outflow as water in a reservoir exceeds the maximum capacity [13], (B) and (C) photographs captured from video clip taken during the failure incident, showing an internal erosion through dispersive soil [14], (D) an aerial view showing a breached location and water in the reservoir [14].

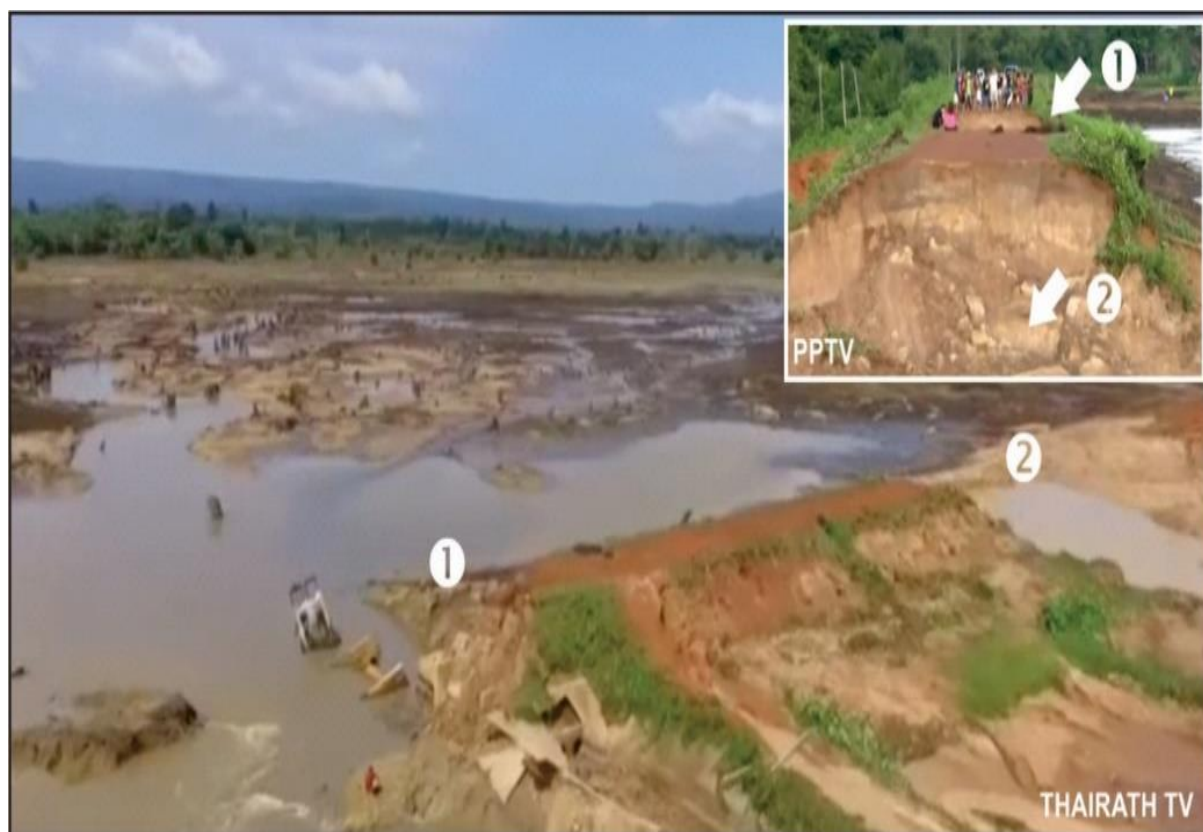
Figure 4 An aerial view showing the two breached sites of the Huai Sai Kamin embankment, one site at the left water gate and about 25 meters away from the other site. An insert photo shows embankment cross section in the opposite view [11,18].

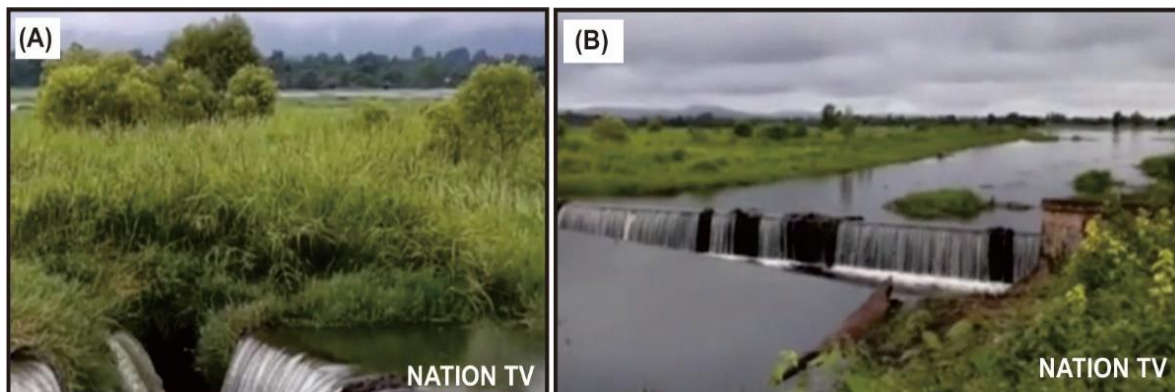
Figure 8 (A) Photograph showing the spillway blockage with water weed [25], (B) a wide view showing thick and dense water weed floating close to the spillway [25].

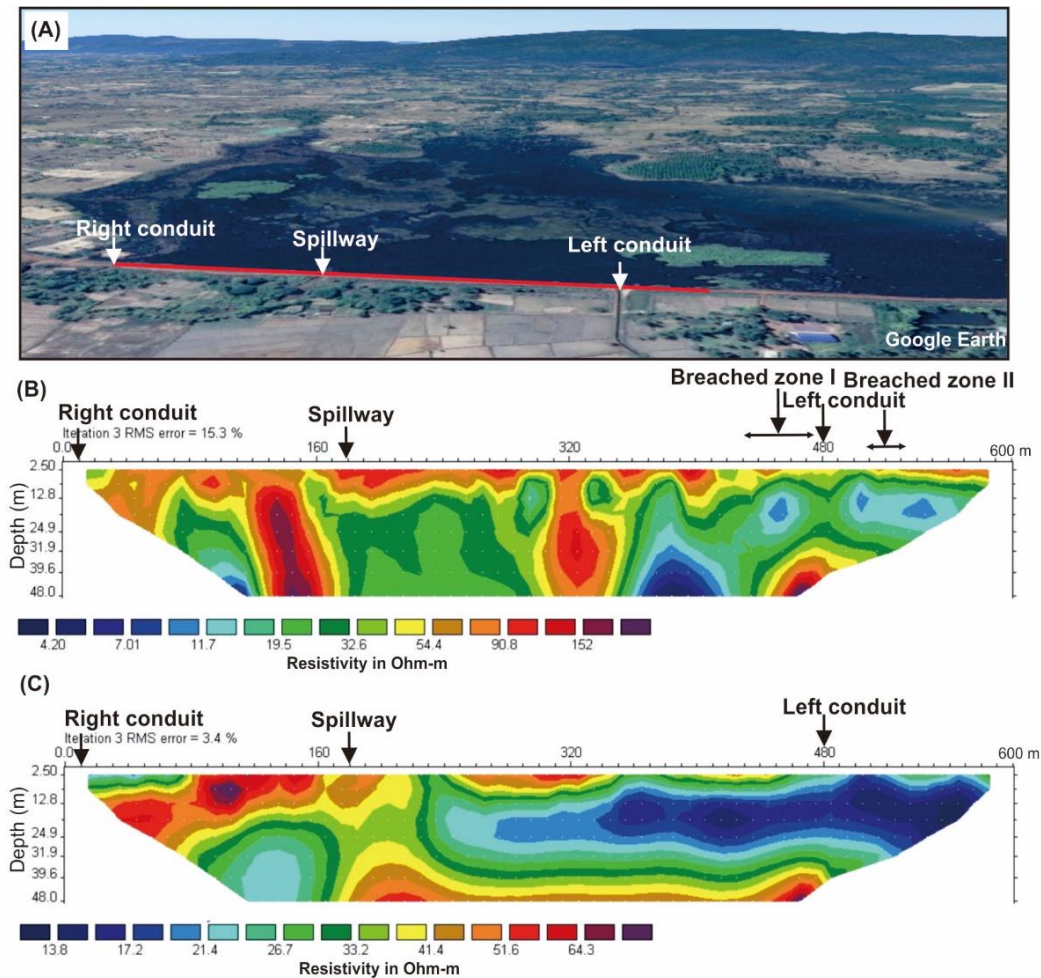
Figure 9 (A) shows resistivity locations that were acquired at the Huai Sai Kamin dam. Figure 9 (B) displays resistivity section acquired along the top of embankment. Figure 9 (C) shows resistivity section acquired along the downstream toe of embankment. Subsurface anomaly of low resistivity zone was evident between the distances of 440-470 m and 12-25 m deep in Figure 9 (B). This low resistivity zone corresponded with a body of river channel of the Huai Nam Bo tributary as surface evidence shown on aerial photographs in Figures 1 (D). This zone was the deepest breaching zone occurred (Figures 1 (A), 4 and 9 (C)). Figures 1 (A), 4 and 9 indicate that the Huai Sai Kamin embankment was built on top of the Huai Nam Bo tributary. The remnant channel of the

Huai Nam Bo tributary was the weakest zone accounting for the failure at the base of the Huai Sai Kamin dam. Figure 9 (C) shows a low resistivity zone existed between the distances of 230-580 m and 0-32 m deep. Based on soil testing results presented in Table 3, the low resistivity zone in Figure 9 (C) was a high moisture content zone, not a zone with high clay content. The local soil nearby the embankment is SP or SW.

Figure 9 (A) An oblique view of the Huai Sai Kamin embankment from Google Earth showing 2-D resistivity line location that was acquired in 2009 [26-27], (B) pseudosection of the 2-D resistivity along the top of the embankment, where high moisture zone is indicated at the left embankment [27-28], (C) pseudosection of the 2-D resistivity along the downstream toe of the embankment, where a high moisture content is indicated at the left [27-28].

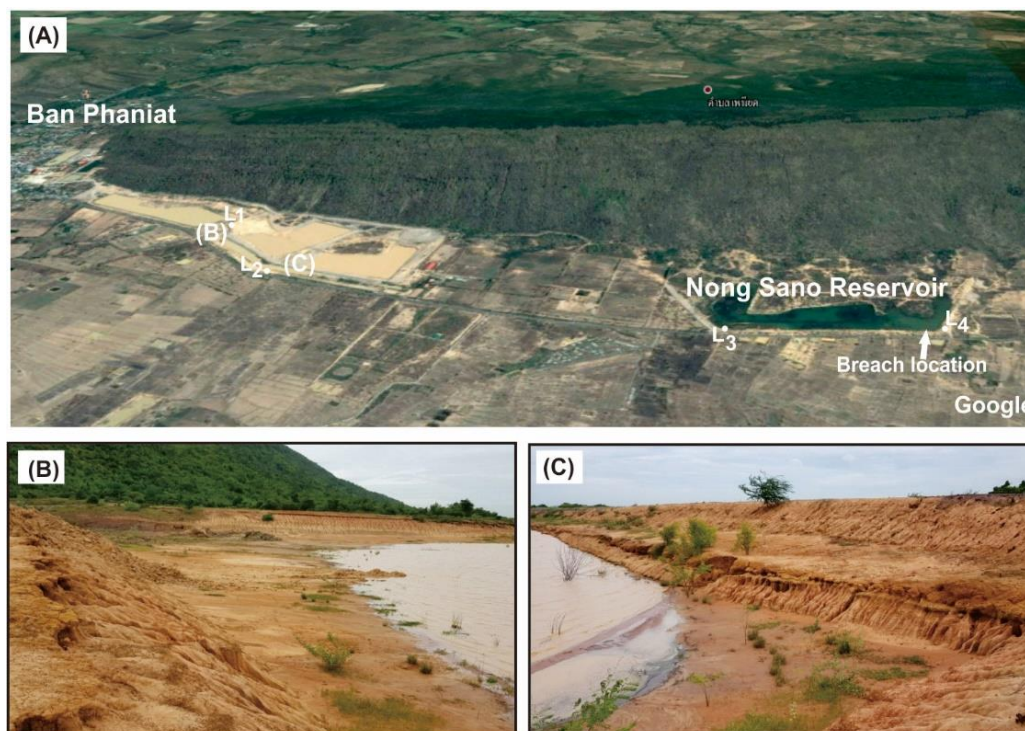
Figure 10 (A) A satellite oblique view of the Nong Sano reservoir and another three reservoirs nearby [29], L₁-L₄ are locations of soil samples, (B) and (C) photographs taken from the location marked in (B) and (C), showing gully erosion feature and milky water in the reservoirs.
