Geotechnical investigation of the 2017 earth-filled embankment failures in Thailand

Peangta Satarugsa*, Kiattisak Sonpirom, Phopthorn Maneepong and Natthawiroj Silaratana

Department of Geotechnology, Faculty of Technology, Khon Kaen University, Khon Kaen, Thailand

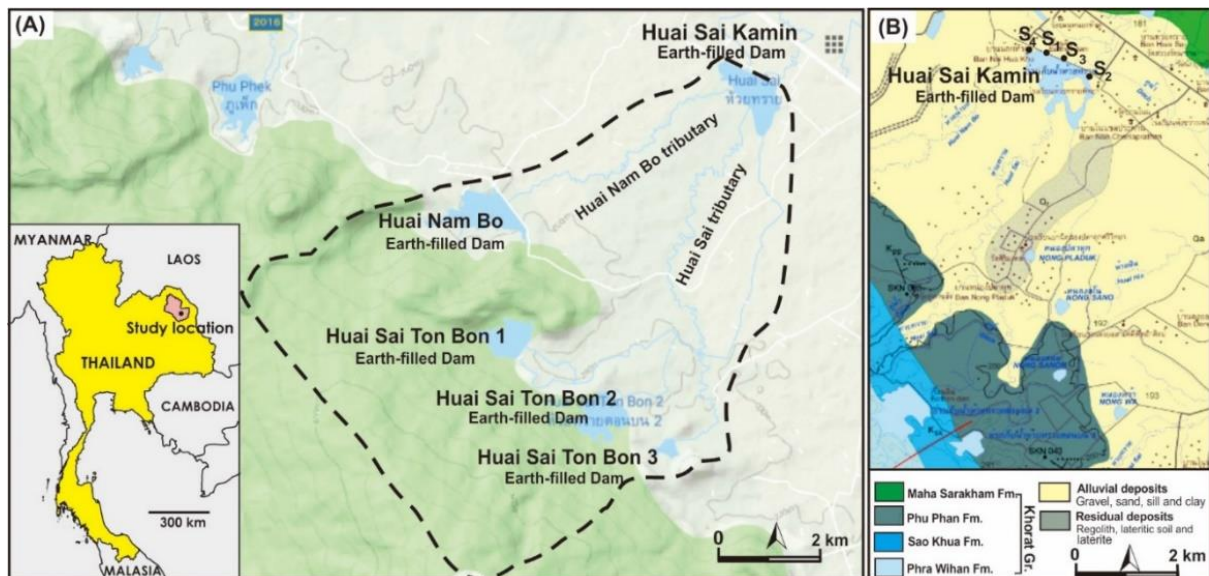
Figure 3 (A) Google map showing the topography of the Huai Sai Kamin dam and another four dams located upstream and within its catchment area; the catchment area is outlined by dash line [15]. An insert at the bottom left corner is an index map showing Thailand and study location. (B) Geologic map showing surface geology of the Huai Sai Kamin dam and surrounding areas, where soil samples were collected at 4 sites (S₁-S₄) [16].

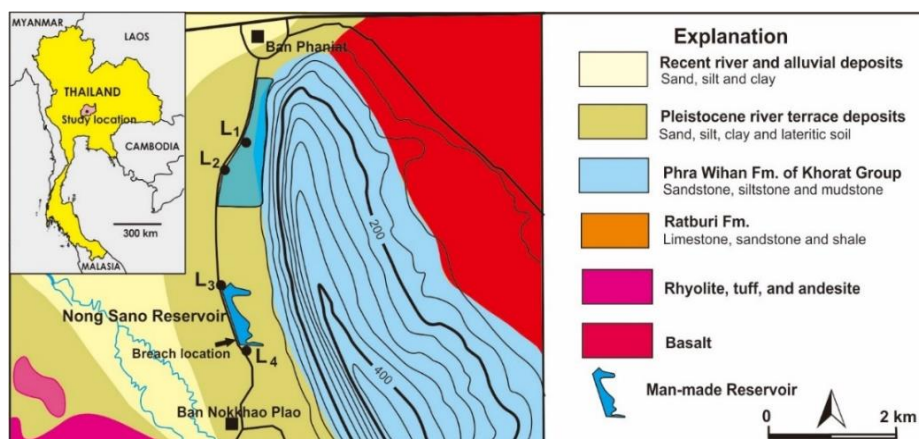
Figure 5 Geologic map showing surface geology of the Nong Sano reservoir and surrounding areas. Soil samples were obtained at 4 sites (L1-L4) [19]. An insert at the top left corner is an index map showing Thailand and study location.

Surface geology of the Huai Sai Kamin dam and the Nong Sano reservoir are shown in Figures 3 (B) and 5 together with their surrounding areas. The Huai Sai Kamin dam is situated on alluvial deposits that are composed of gravel, sand, silt and clay particles. Sources of these particles were mainly weathered and eroded from sedimentary rocks of the Khorat Group as indicated in Figure 3 (B). The Nong Sano reservoir is situated on Quaternary terrace deposits that are composed of sand, silt, clay and laterite. Sources of the terrace deposits were probably weathered and eroded from sedimentary rocks of the Khorat Group and from extrusive igneous rocks as evident in Figure 5. Tables 2 and 3 present test results of samples of materials from embankments and nearby the embankments, respectively. According to the USCS, the soil used for constructing the Huai Sai Kamin embankment is clayey sand (SC) and is not dispersive soil. The soil used as a construction material for Nong Sano embankment is sandy lead clay (CL) and consists of dispersive (Grad 3). The soils nearby the Huai Sai Kamin embankment are well graded-sand with gravel (SW) or poorly graded sand with gravel (SP) and non-plasticity (NP), while the soils nearby the Nong Sano embankment are poorly graded sand with gravel (SP) and non-plasticity (Table 3). The soils nearby these two embankments are mostly sand particles with few silt and clay particles. Data in Tables 2 and 3 indicate that silt and clay particles used for constructing these two embankments were not close to ground surface (30 cm. ground surface) at the dam site. Hence, silt and clay particles were below 30 cm or they were borrowed from other places. Moreover the clay particle used for constructing the Nong Sano embankment is dispersive clay. According to geologic map shown in Figure 5, sources of the dispersive clay at the Nong Sano reservoir appear to be resulted from weathering and erosion of extrusive igneous rocks, basalt, rhyolite, tuff and andesite.

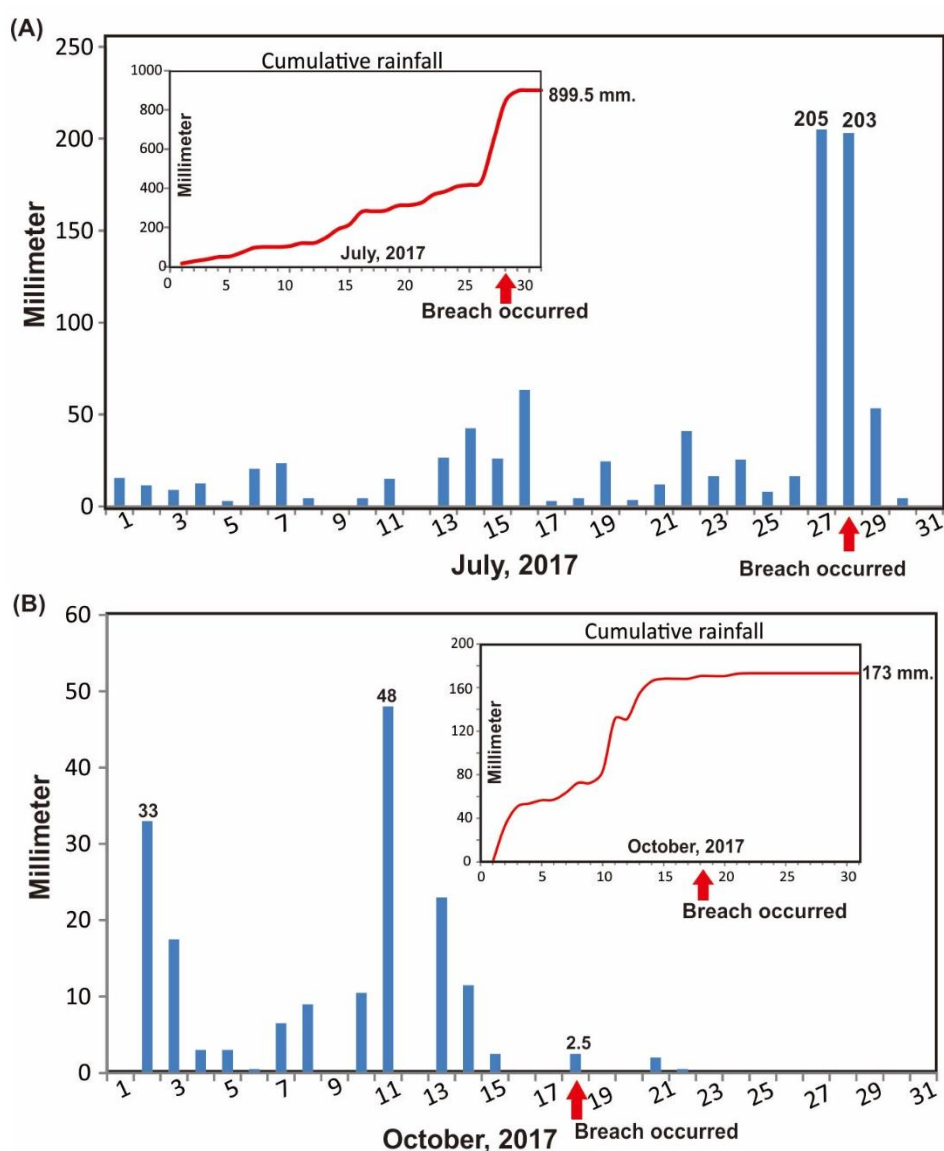
Figure 6 (A) provides daily rainfall for July 2017 recorded by the rain gage station nearby the Huai Sai Kamin dam. Figure 6 (B) provides daily rainfall for October 2017 recorded by the rain gage station nearby the Nong Sano reservoir. The Huai Sai Kamin embankment was breached on July 28th, and according to data shown in Figure 6 (A) the amount of rainfall was 203 mm, i.e., heavy rainfall. Water capacity in the reservoir was exceeded a maximum capacity of 127% [4]. The Nong Sano embankment was breached on October 18th, 2017, and according to data in Figure 6 (B), the amount of rain was 2.5 mm. Figure 6 (B) indicates the Huai Sai Kamin embankment breached as a result of heavy rainfall.

Figure 6 Daily rainfall and cumulative rainfall for July 2017 recorded by (A) the rain gage station nearby the Huai Sai Kamin dam [24], (B) daily rainfall and cumulative rainfall for October 2017, recorded by the rain gage station nearby the Nong Sano reservoir [24].

As indicated in Figure 6 (B), a cumulative monthly rainfall of the Nong Sano reservoir was 173 mm. The amount and pattern of rainfall differed from the case of the Huai Sai Kamin dam. No evidence of heavy rainfall hit the Nong Sano reservoir during its failure. Further, the failure occurred at the time when amount of water in the reservoir was below the reservoir maximum capacity. Figure 2 (A) displays gully erosion at the embankment of the Nong Sano reservoir. The gully erosion was obviously evident and the gully erosion appearing in Figure 2 (A) is the evidence of dispersive clays. Hence the failure of the Nong Sano reservoir is a result of piping erosion resulting from using dispersive clay as an earth-filled material. Figure 10 displays three additional reservoirs close to the Nong Sano reservoir, where the gully erosion and milky water were more obviously evident than the Nong Sano reservoir. Hence, it is envisaged that a similar failure will repeat if no proper treatment and/or proper reconstruction is undertaken for the Nong Sano reservoir and the other three reservoirs nearby.

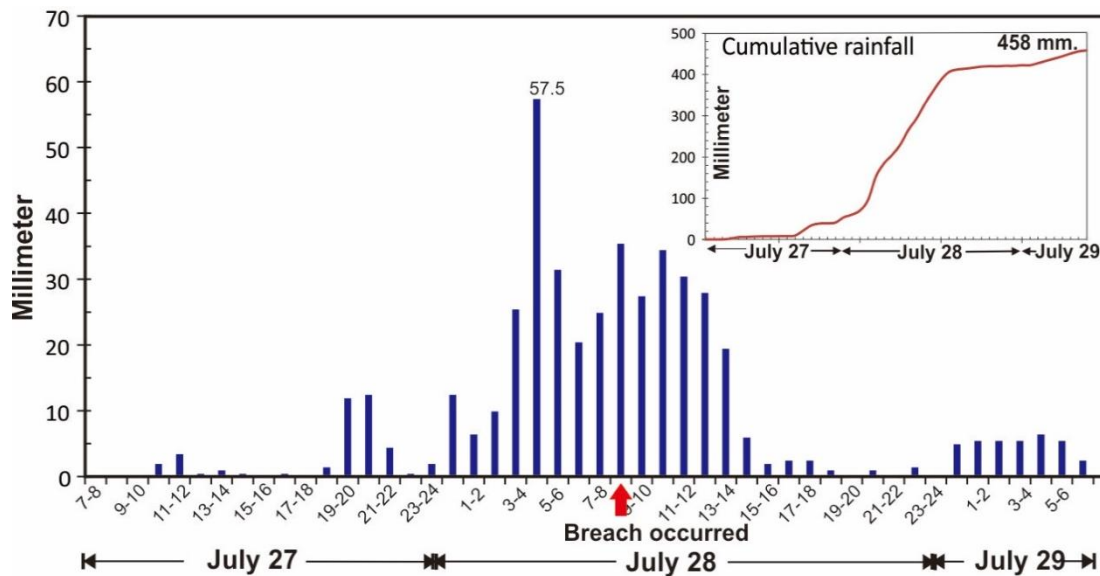
Figure 7 displays the rainfall over 48 hours from 7.00 a.m. of July 27th to 7.00 a.m. of July 29th, 2017 recorded by the rain gage station nearby the Huai Sai Kamin dam. As reported by local people, the Huai Sai Kamin embankment was breached around 8.00-9.00 a.m. of July 28th but the rain continued till 6.00 p.m. A cumulative rainfall between 7 a.m. of July 27th to 10.00 a.m. of July 28th was 344 mm. The dam was breached as a result of water overtopping of the dam. The water overtopping later triggered the dam to breach. Although the dam has a spillway with a rate of 85 m³ per second (Table 1), this capacity appeared to be inadequate with the resultant water overtopping. Moreover, Figure 8 shows dense and large debris of water weed and water plants that blocked water flow to the spillway. These dense and large debris volumes reduced the spillway capacity. The dense and large water weed and water plants indicated an inadequate maintenance of the dam. Figure 4 displays the breach occurred at two locations, near the left end of the embankment and at the left irrigation conduit. In fact, the breach occurred at the conduit was not unusual as it was already anticipated as a high failure prone.

Figure 7 A 48-hour rainfall from 7.00 a.m. July 28th to 7.00 a.m. July 29th, 2017, recorded by the rain gage station, nearby the Huai Sai Kamin dam [24].
